Manhole Inspection Summary

Manhole # S33OO_019MH

Location Address: **2302 HOWARD ST**

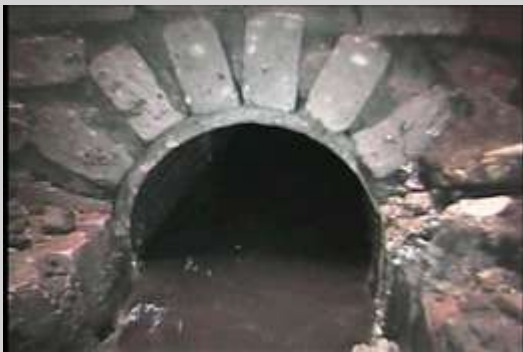
10 in. Circular Gravity Sewer Pipe Out @ 12 O'Clock

Deposits: ☒ None ☐ Mud ☐ Sludge ☐ Debris ☐ Grease

Infiltration: **None** Pipe Seal Cond: **Unknown**

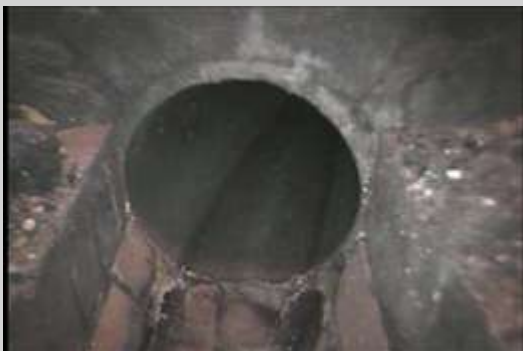
8 in. Circular Gravity Sewer Pipe In @ 6 O'Clock

Deposits: ☒ None ☐ Mud ☐ Sludge ☐ Debris ☐ Grease

Infiltration: **None** Pipe Seal Cond: **Unknown**

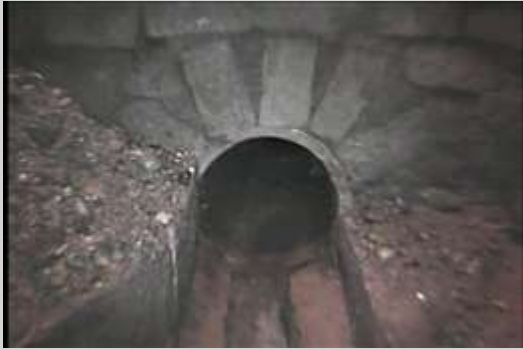
6 in. Circular Gravity Sewer

Infiltration: **None**
